### **APOLLO SPACECRAFT**

**REPORT OF PANEL 5  
ORIGIN AND PROPAGATION OF FIRE  
APPENDIX D-5  
TO  
FINAL REPORT OF  
COLLO 204 REVIEW BOARD**

## **ORIGIN AND PROPAGATION OF FIRE**

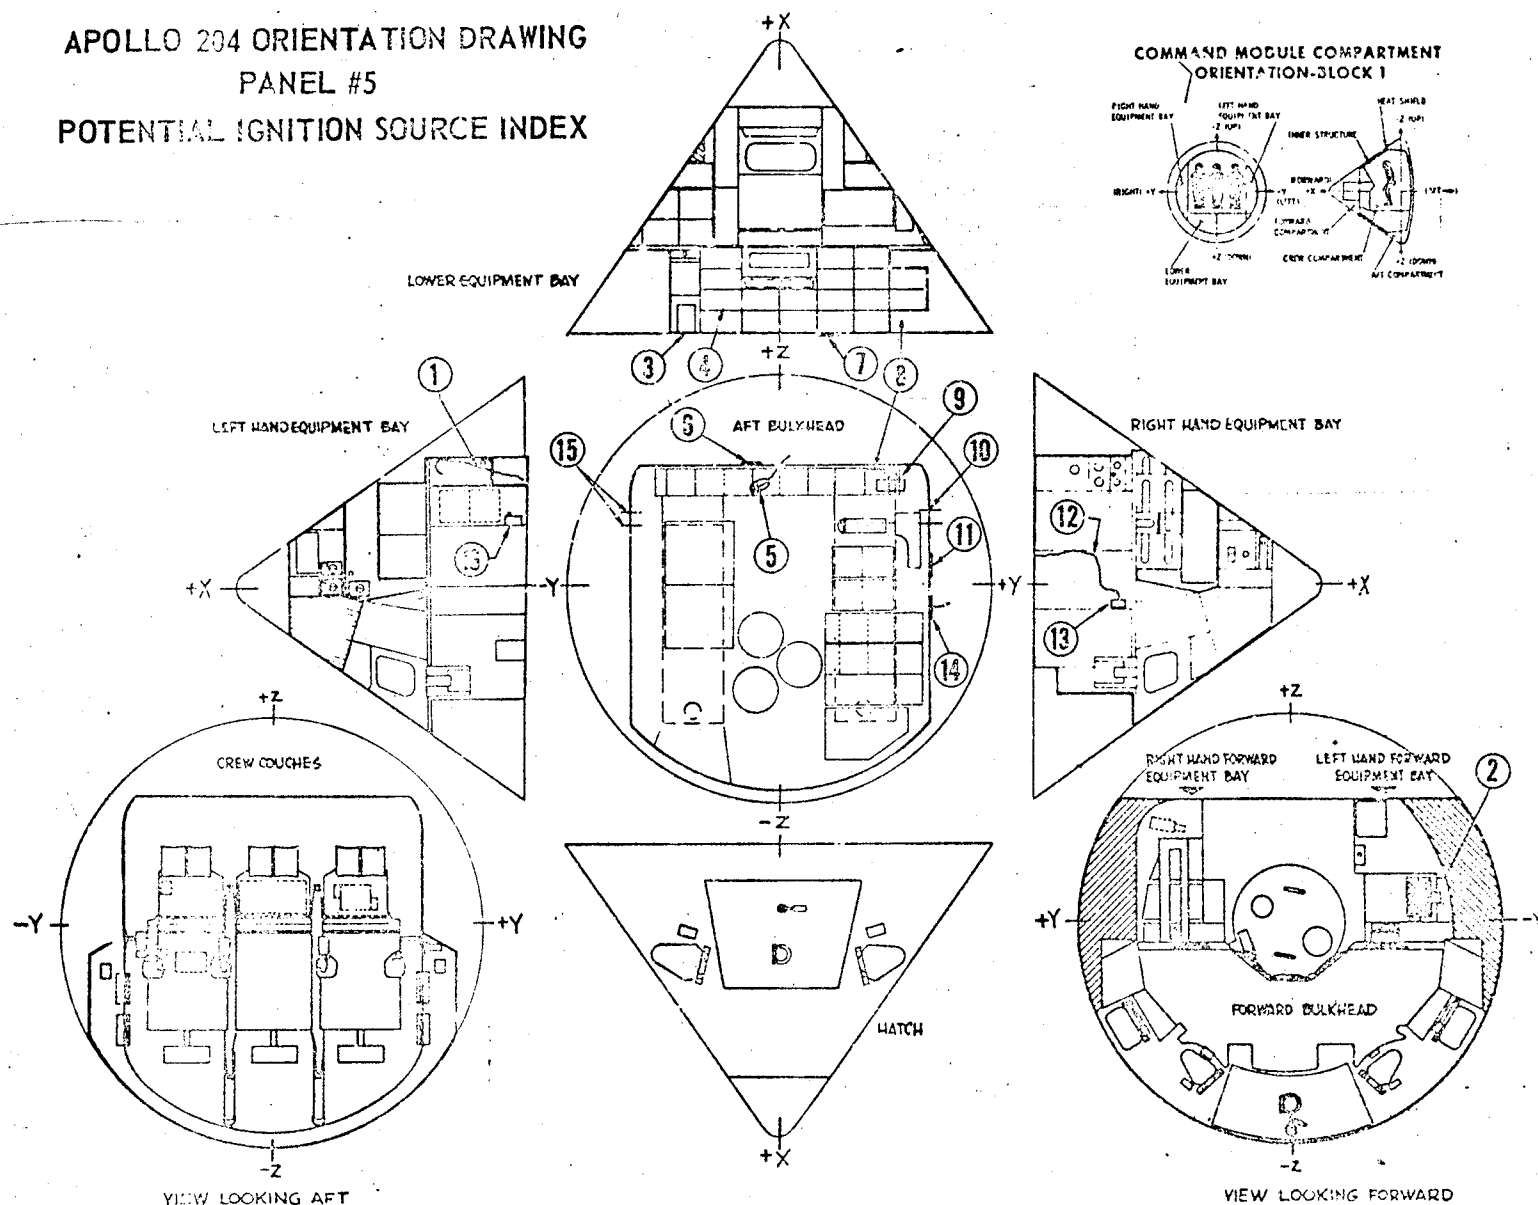
ENCLOSURE 5-4

# ELECTRICAL SYSTEM DAMAGE

3.	G-15	Outboard harness and inboard harness in LEB run below gas chromatograph installation. Significant damage is seen to have occurred to the outboard run with minor damage to the inside of the inboard run.

15.	L-14	Wire bundle running outboard under hinged LiOH canister door. Fraying is seen in the top of this bundle at the attenuator line.
16.	L-11	Connector panel for ECU in LHEB. Damage to connectors is seen on top side, but less severe on bottom side of these connectors.

18.	L-14	Severely burned residue from wire bundle running under brace for wall between LiOH canister and remainder of ECU.
19.	F-17	Wires severely burned, melted and fused in Channel H.

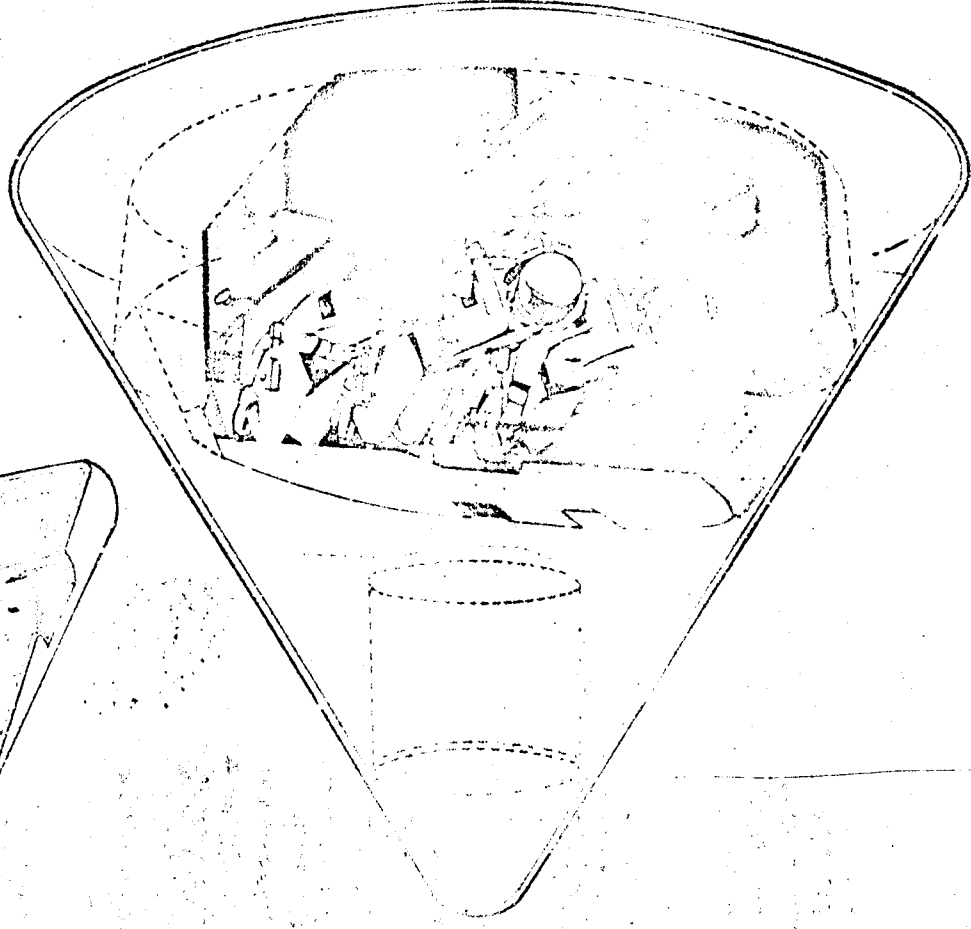
ENCLOSURE 5-7

- VELCRO
- HYALINE
- RASCHEL KNIT
- TRILOCK AND RASCHEL COVERING
- RASCHEL KNIT (AFT BULKHEAD)
